PROCEDURE

1.INSPECT NO. 1 CHAIN TENSIONER SUB-ASSEMBLY

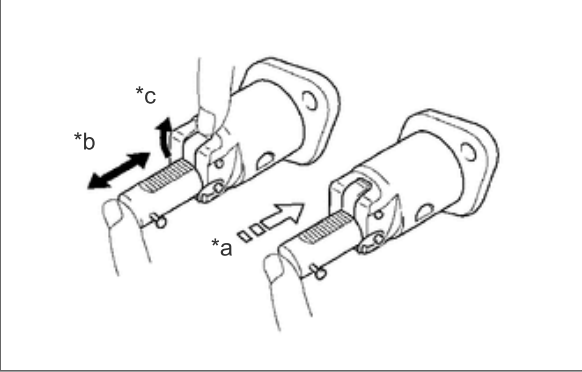
*a	Raise
*b	Move
*c	Lock

Check that the plunger moves smoothly when the ratchet pawl is raised with your finger.

- b. Release the ratchet pawl, then check that the plunger is locked in place by the ratchet pawl and does not move when pushed with your finger.

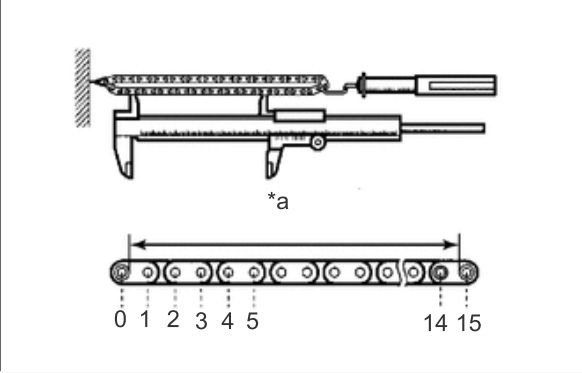
*a	Measurement Length
----	--------------------

Pull the chain sub-assembly with a force of 140 N (14 kgf, 31.5 lbf) as shown in the illustration.

- b. Using a vernier caliper, measure the length of 15 links.

Maximum Chain Elongation:
122.6 mm (4.827 in.)

NOTICE:
Perform the measurement at 3 random places. Use the average of the measurements.

If the average elongation is greater than the maximum, replace the chain sub-assembly.
